# POSSE TECHNOTES

Volume 1, No. 1 / Summer 1999

## NAVSEA Supports Salvage of M/V Concorde Spirit

## USS RADFORD Collision Initial Damage Assessment and Drydocking Evaluation

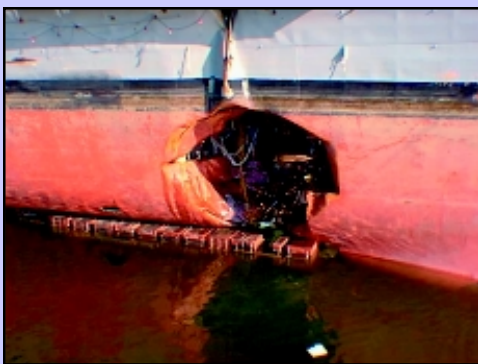
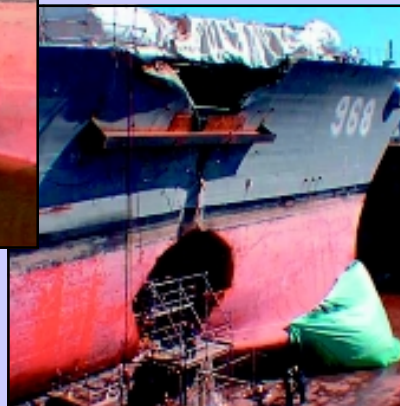
On 5 February 1999, while conducting exercises off Hampton Roads, VA, the USS Arthur W. Radford was involved in a collision at sea with a Saudi Arabian container vessel. The Saudi vessel's stem and bulbous bow penetrated the starboard side of the Radford, centered near frame 69 (approximately at the location of the forward 5" gun mount). As a result of the collision, the Radford experienced significant structural damage and flooding from frames 58 through 94, with additional flooding within sonar equipment spaces between frames 29 and 58. Post damage inspections indicated that flooding was complete (free-flooded to the waterline). Structural damage from the stem of the Saudi vessel consisted of complete penetration of the side shell and main deck from the 1<sup>st</sup> platform deck (24' above baseline) on the side shell to the ship's centerline on the strength (01) deck, with damage ex-

tending mainly from frames 52 through 84. Additional structural damage below the waterline from the bulbous bow of the Saudi vessel consisted of complete penetration of the side and bottom shell from the 2<sup>nd</sup> platform deck (15' above baseline) to the center vertical keel at the baseline, with damage extending mainly from frames 64 through 82. Outside these primary penetration areas, there was significant buckling of decks and tripping of stiffeners caused by the transverse force of the collision. Thus, many of the structural members outside the primary penetration area provided reduced effective strength to the hull girder.

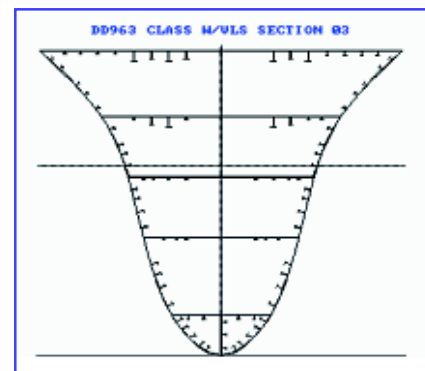
Intact longitudinal structure at frame 69

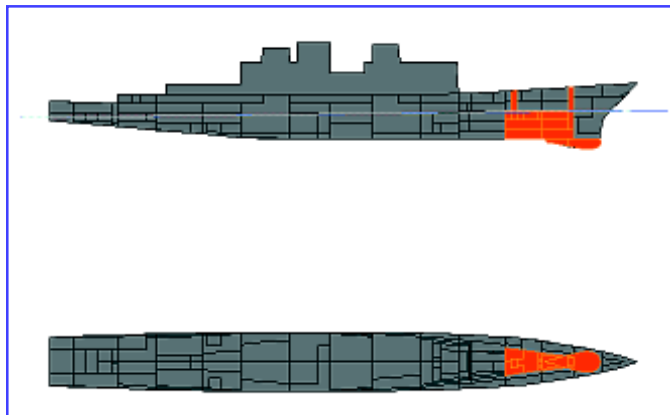
Initial damaged condition with free-flooding of the damaged compartments

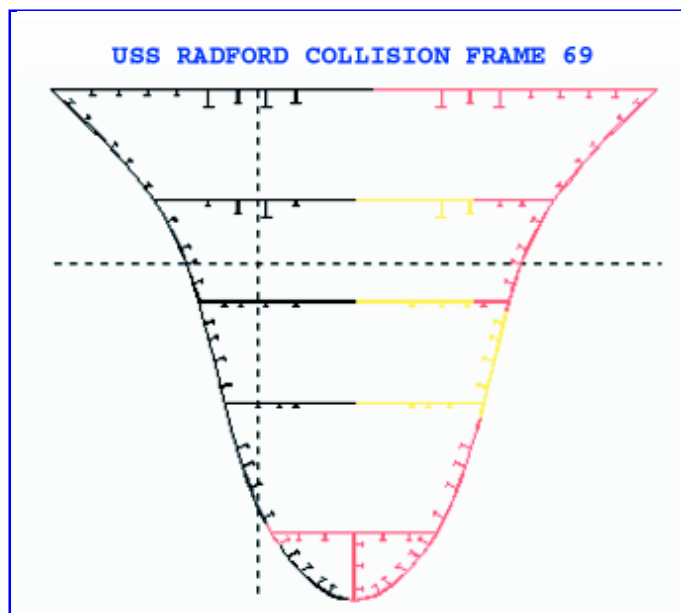
elements' effectiveness was reduced by applying a "corrosion" factor, reducing the contribution of the elements to the section moduli and shear area calculations. The damaged section (e.g. at frame 69) was calculated to have lost up to 60% of it's original section moduli (to both keel and deck) and approximately 35% of it's shear area about it's horizontal neutral axis (i.e. for vertical bending and shear).

POSSE calculated bending and shear stresses in way of the damaged section. Maximum stresses were under 30 ksi compression at the keel and 15 ksi tension at the strength (01) deck for bending, and under 5 ksi for shear for all potential damaged load cases envisioned. As the hull structure is primarily HTS (High Tensile Strength) steel, with a nominal yield strength of approximately 51 ksi, there was a factor of safety of less than 1.8 to yield in the extreme elements of the keel (compressive yielding). It should be noted that POSSE utilizes prismatic beam theory in evaluation of hull girder stresses. Thus, bending stresses are assumed to vary linearly across the section, with maximums at the extreme elements (keel and deck). Actual stresses do not vary linearly due to non-linear phenomenon of shear flow and shear lag. However, for purposes of evaluating risk of hull girder failure, experience has shown that this approach is reasonably accurate, provided non-linearities are considered and suitable factors of safety to hull girder failure are provided for.

*Damaged structural section at frame 69 (black = fully effective, red = ineffective, yellow = partially effective)*

In order to increase the factor of safety to yield in the damaged structural section, additional stiffening members were fabricated and welded to the hull. Three large (36" T) beams were welded to the strength (01) deck, and one large (36" T) beam was welded to the starboard side shell at the main deck level. These stiffening members had the net effect of increasing the section moduli of the damaged section by approximately 10-15% thus reducing maximum bending stresses by 9-14% in the damaged section.

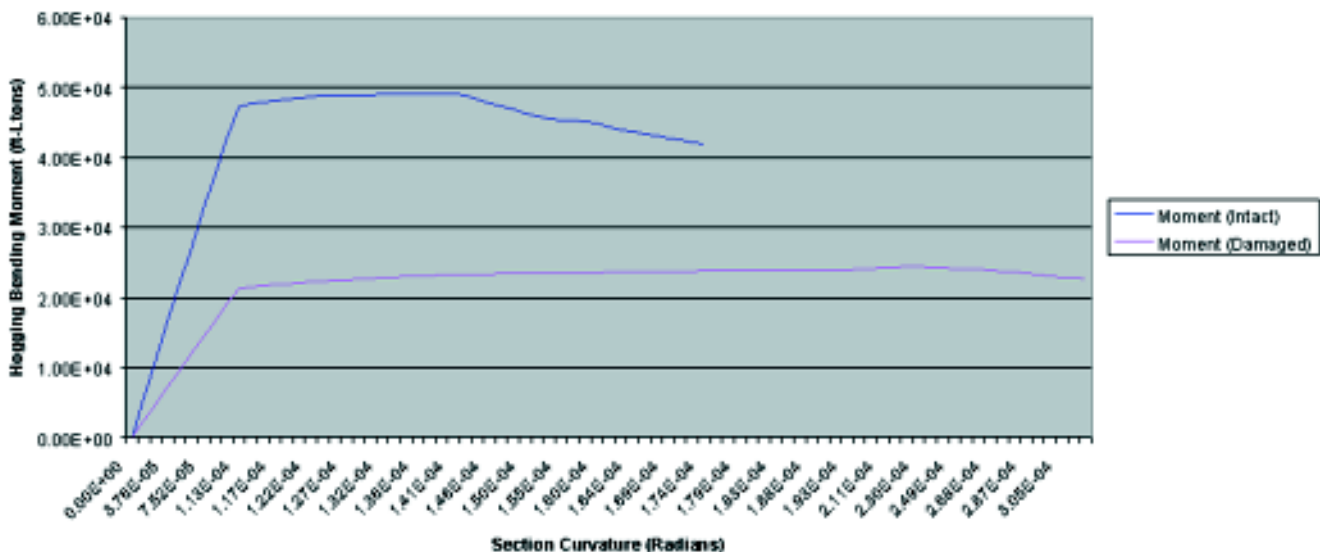
USS Radford  
Ultimate Bending Moment Capacity (Hogging) using ULSTR  
Section Frame 69 (Intact & Damaged)

less than 1.7 to hull girder collapse). Additionally, the "limit state" analysis indicated that initial failure mechanisms were associated with tripping of stiffeners and buckling of "beam-column" elements (stiffened panel elements), initiating at bending moment levels as low as 22,000 ft-Ltons. The maximum calculated vertical bending moment in any damaged load case envisioned was approximately 15,000 ft-Ltons. Thus, factor of safety to initial hull girder element compressive failure was calculated to be less than 1.5.

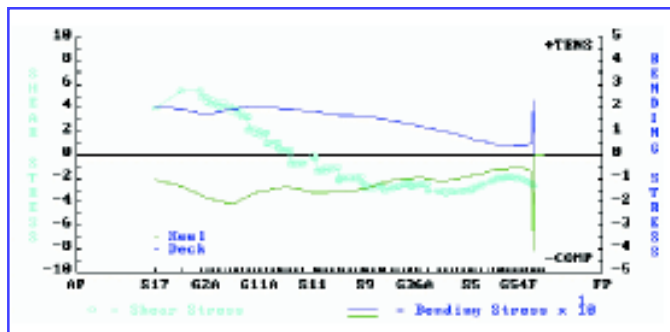
Longitudinal stress distribution in drydock, sonar dome full

Predicted longitudinal bending and shear stresses are presented below. Bending stress at the damage section was expected to reach 41 ksi at the keel (compression) and 23 ksi at the strength deck (tension). The predicted bending moment at the damaged section was calculated to be approximately 24,500 ft-Ltons, which would be in excess of the ultimate bending moment capacity of the damaged section, calculated based on ULSTR analysis. This was clearly undesirable.

- (1) Dewater the sonar dome prior to emptying the drydock or dewatering the sonar dome during the drydock dewatering process, but prior to the drydock becoming empty. This provides reduced bending moments at the damaged section. Bending stress at the damage section with the sonar dome dewatered were calculated to be reduced to approximately 33 ksi at the keel (compression) and 19 ksi at the strength deck (tension).
- (2) Add drydock blocking under the sonar dome foundation (bellyband), thus reducing bending moments across the damaged section. In order for this to

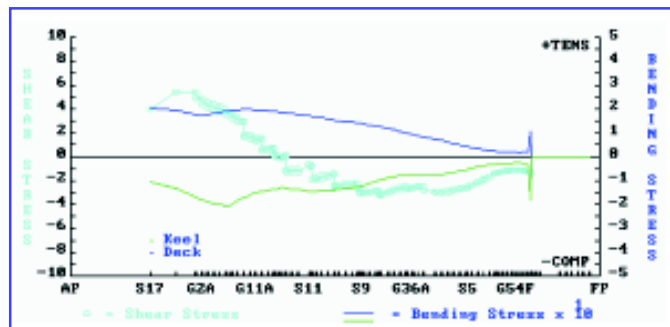
Longitudinal stress distribution in drydock, sonar dome empty and supported with blocking

achieve much effect on reducing bending moments and stresses, the blocking under the sonar dome would need to have sufficient height to ensure they are sufficiently loaded to reduce bending moments across the damaged section. For example, where blocks under the sonar dome are set  $\frac{1}{2}$ " above the height contour of the sonar dome, bending stresses across the damaged section could be reduced to 18 ksi at the keel (compression) and 11 ksi at the strength deck (tension), providing an acceptable factor of safety to yield.

For the drydocking, Norfolk Naval Shipyard included drydock blocking under the bellyband of the sonar dome. This blocking was set to the sonar dome offset heights, providing sufficient loading of the blocking, since the bow/sonar dome had dropped approximately 1" due to relaxation of the structure since the collision.
